Figure 1

Site Map For 2201/2301 Renaissance Blvd. Showing Pertinent On-Site & Off-Site Features and Soil Sample and Monitoring Well Locations

Renaissance Park
Upper Merion Township
Montgomery County, Pennsylvania

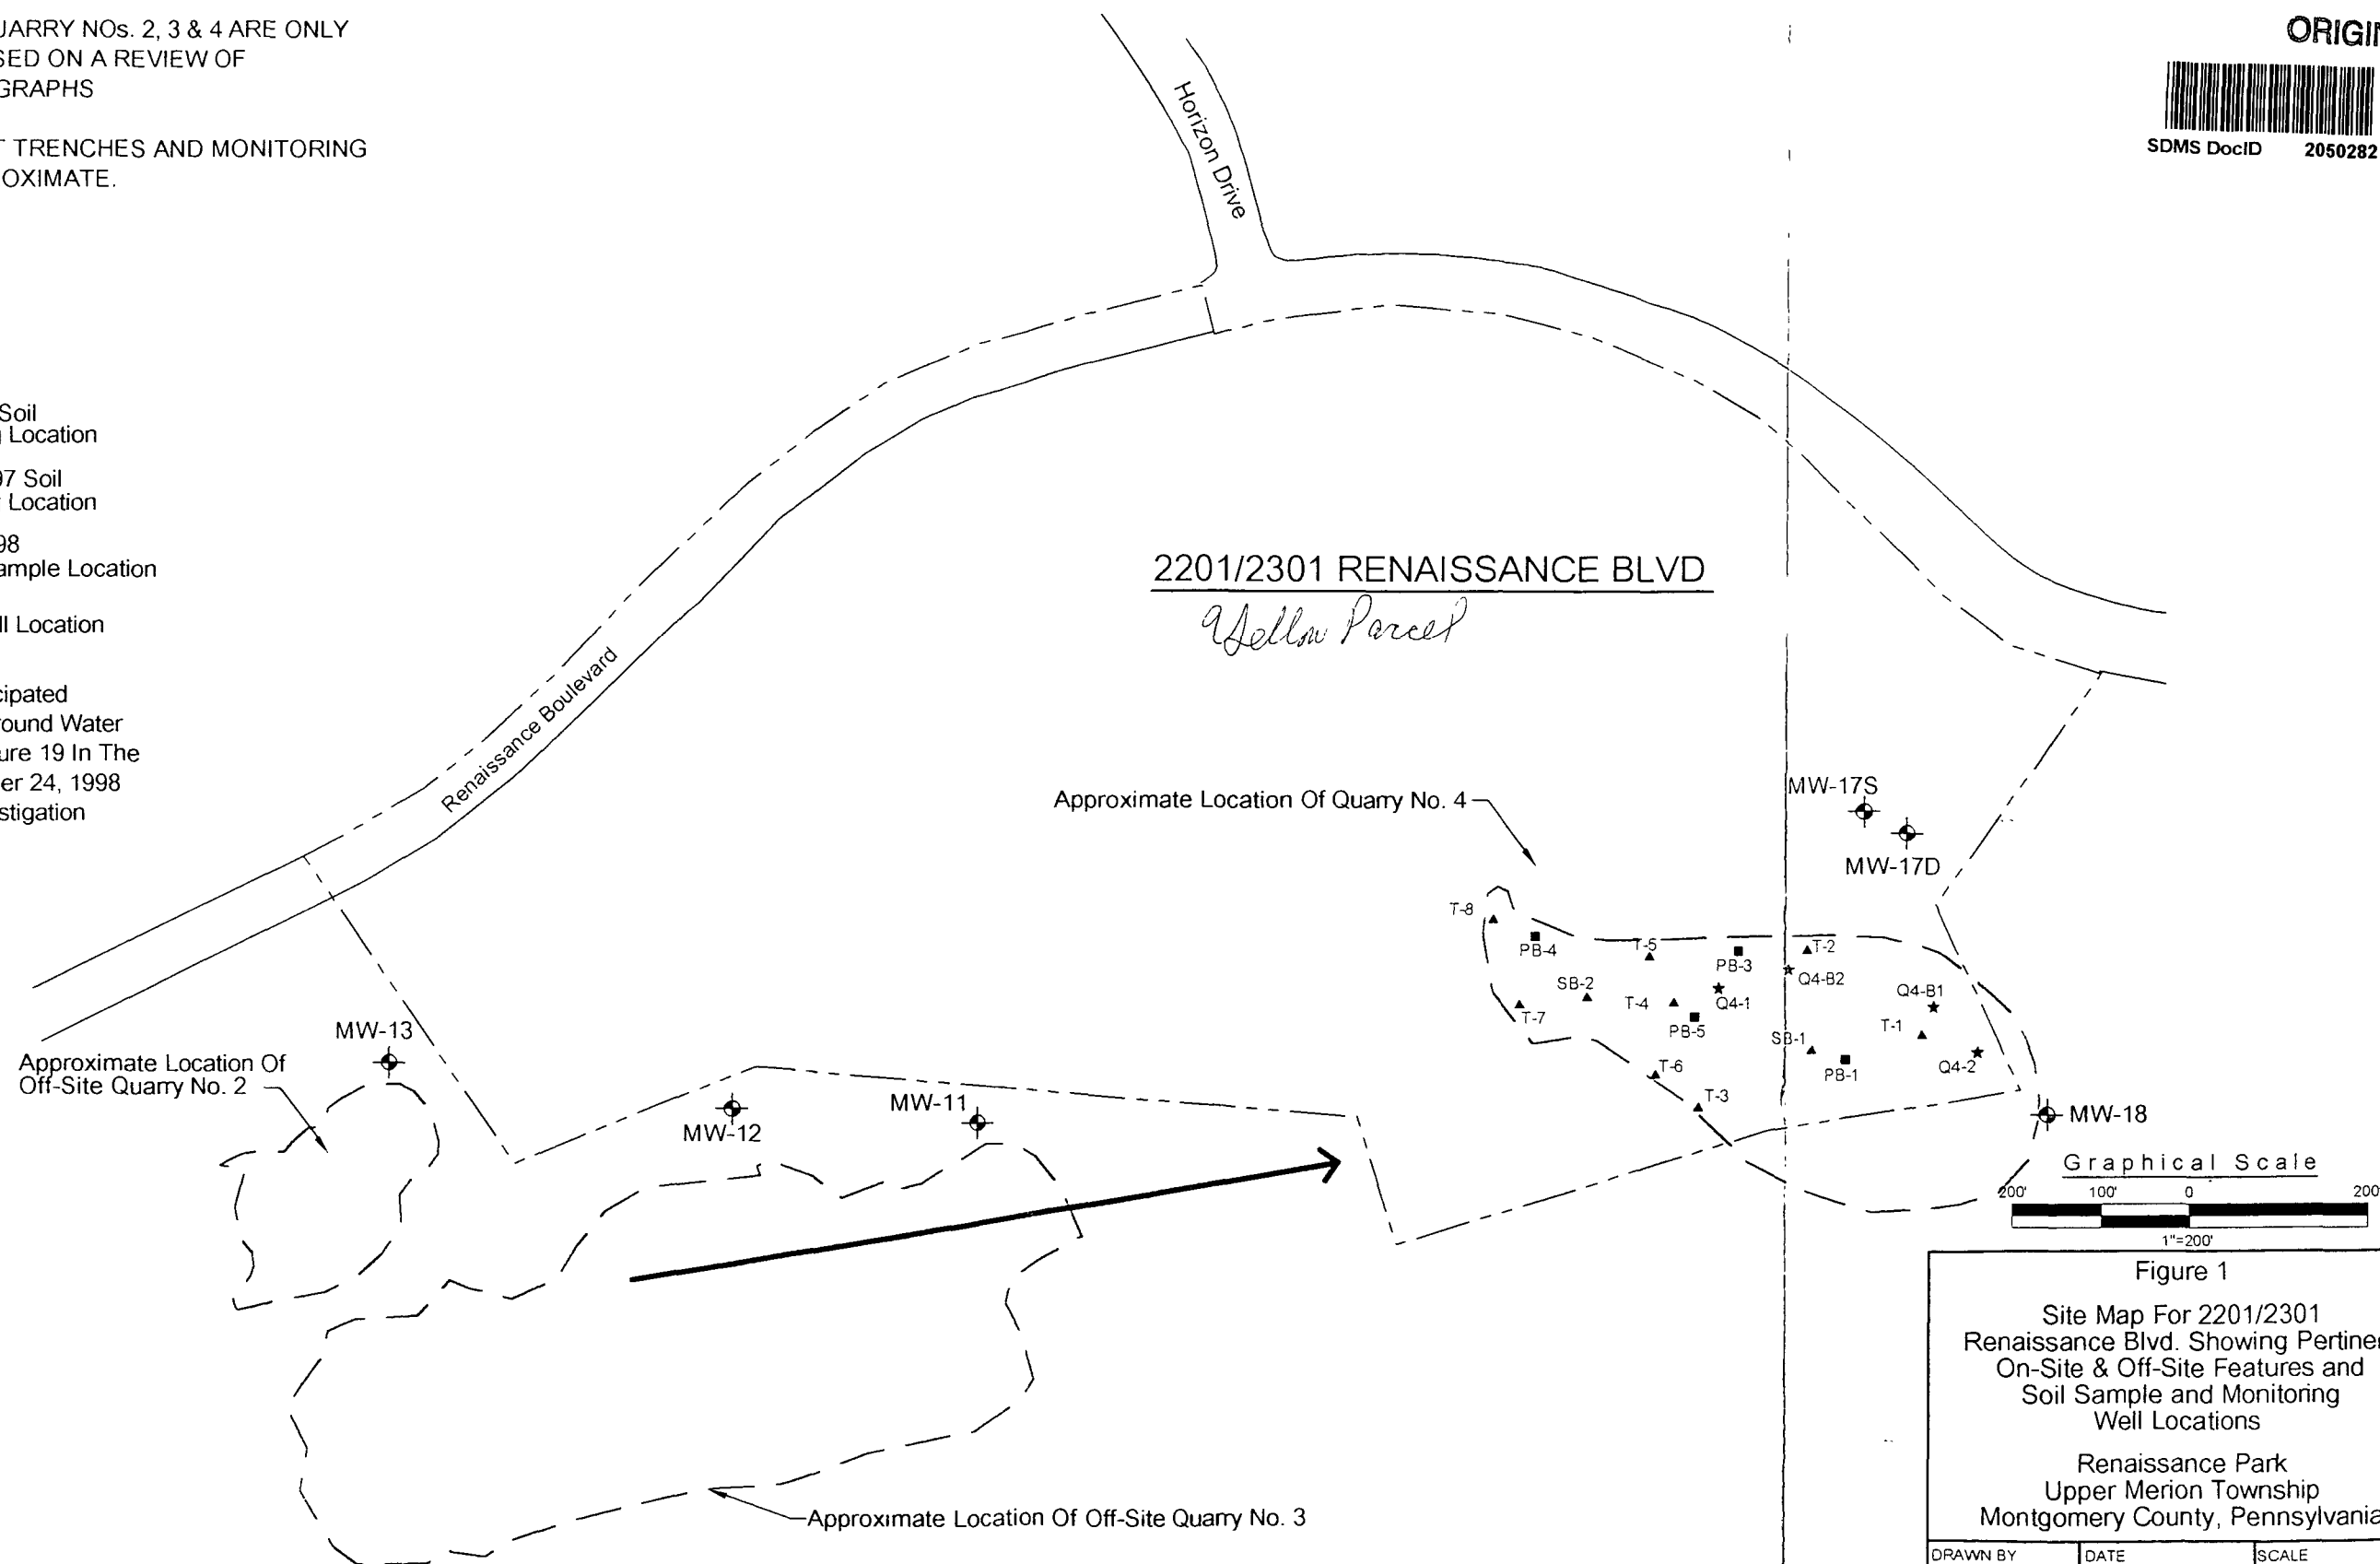
(1) THE BOUNDARIES OF QUARRY NOS. 2, 3 & 4 ARE ONLY APPROXIMATE AND ARE BASED ON A REVIEW OF HISTORICAL AERIAL PHOTOGRAPHS

(2) THE SOIL BORINGS, TEST TRENCHES AND MONITORING WELL LOCATIONS ARE APPROXIMATE.
